**FLOODING OF THE HALL OF JUSTICE,  
ADJACENT FACILITIES AND AREAS WITHIN THE CITY OF FAIRFIELD  
2008-2009 Grand Jury Report**

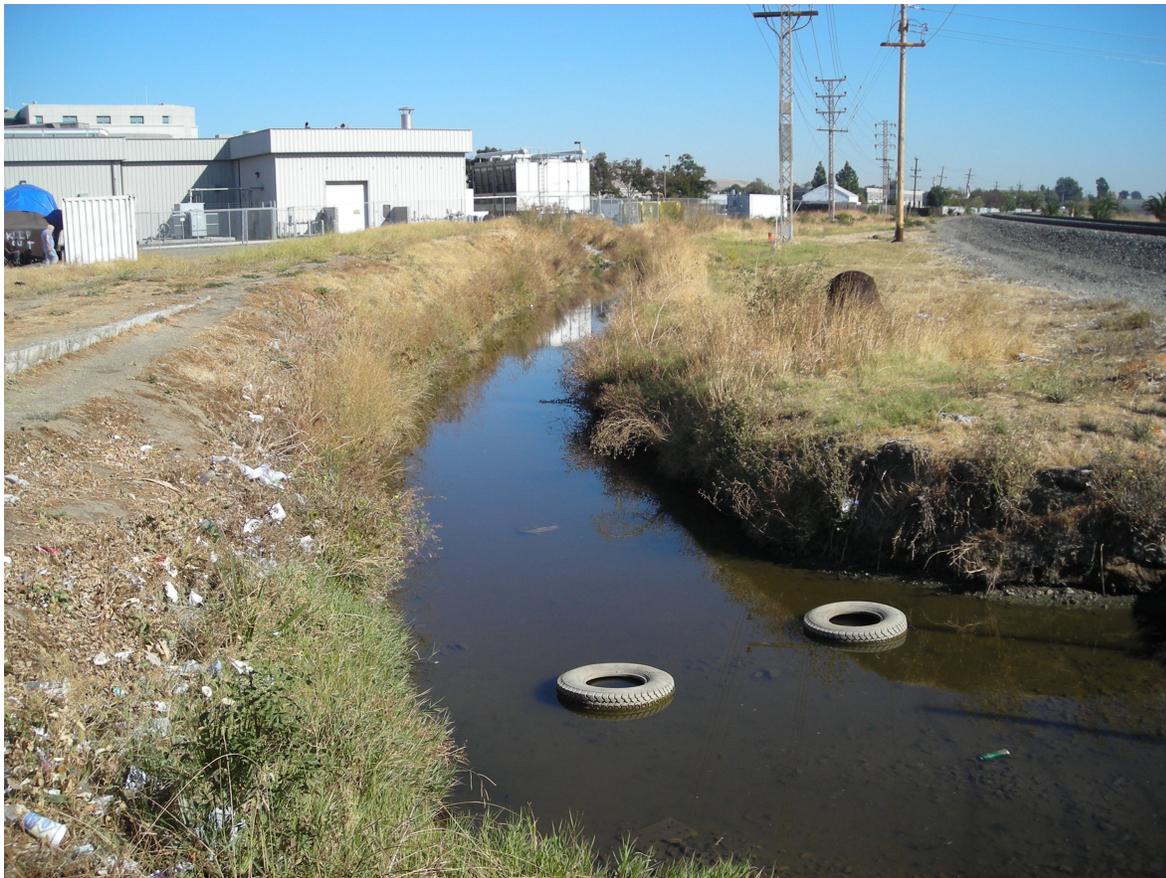
The drainage channel that discharges water from the storm drains is located East of the Hall of Justice and adjacent to the Sheriff's Office. The discharge flows into the Suisun Slough via Union Avenue Creek. This channel exceeded capacity during the last flood. At the time of the inspection by the Grand Jury, the Union Avenue Creek was observed to be about a quarter full of water during dry weather conditions and covered by vegetation on both sides. Assorted floating debris and discarded tires downstream obstructed the flow of water next to the newly replaced railroad crossing over Union Avenue Creek (see photo below).

A view of Union Avenue Creek facing northeast, downstream from Hall of Justice; the railroad crossing is to the right

**Recommendation 3** – The County of Solano and the City of Fairfield should review the four alternatives stated in the March 2008 study and implement the most effective recommendations: New Detention Ponds, New Pumps (Washington Street Station), Upgrades to Storm Drain Boxes and County Pump Station.
